PROJECT NAME  
**Tesla Megapack 2 and  
Megapack 2XL**

DATE SUBMITTED  
**January 23, 2023**

**Fire Protection  
Engineering Analysis**

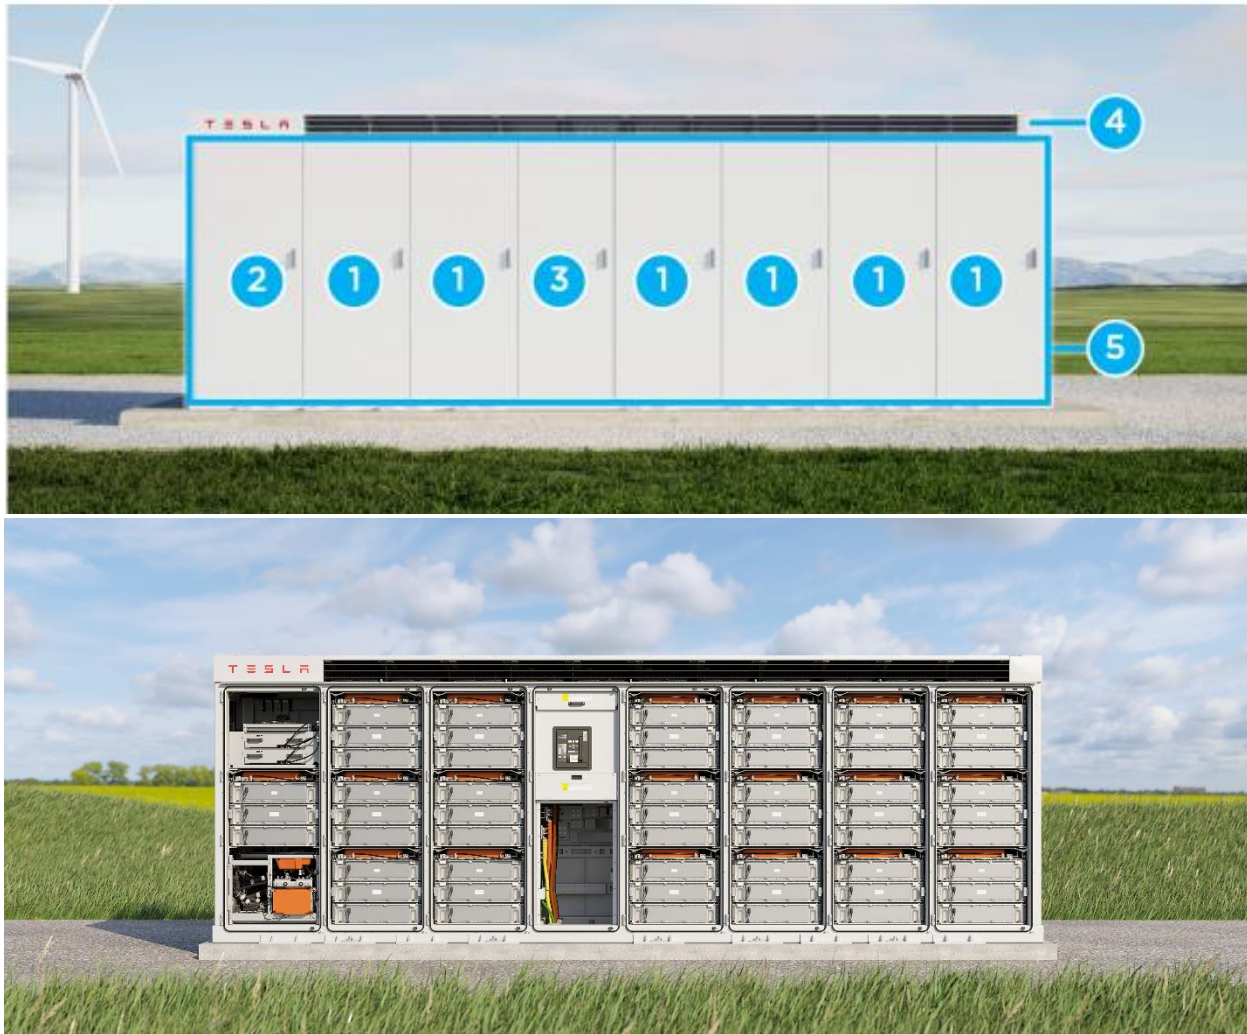
*Figure 1 MP2 internal components: (1) Battery Module Bays, (2) Thermal Bay, (3) Customer Interface Bay, (4) IP20 Thermal Roof Enclosure, (5) IP66 Enclosure.*

The MP2 is intended for outdoor installations, ground mounted to a foundation or base strong enough to support the weight of the equipment and anchor loads (includes concrete pads, grade beams, etc.). The thermal roof (part of the MP2's thermal management system) is enclosed within an IP20 enclosure that sits above the battery module bays, as shown in Figure 1. The lithium-ion batteries are housed inside an IP66 steel enclosure (battery module bay) that provides protection against particle and water ingress coming into contact with the battery modules and power electronics. The IP66 enclosure is one continuous unit, meaning each of the eight bays shown in Figure 1 are open to one another. However, when the MP2 cabinet is populated with battery modules, it cannot be entered. This modular, cabinet style approach

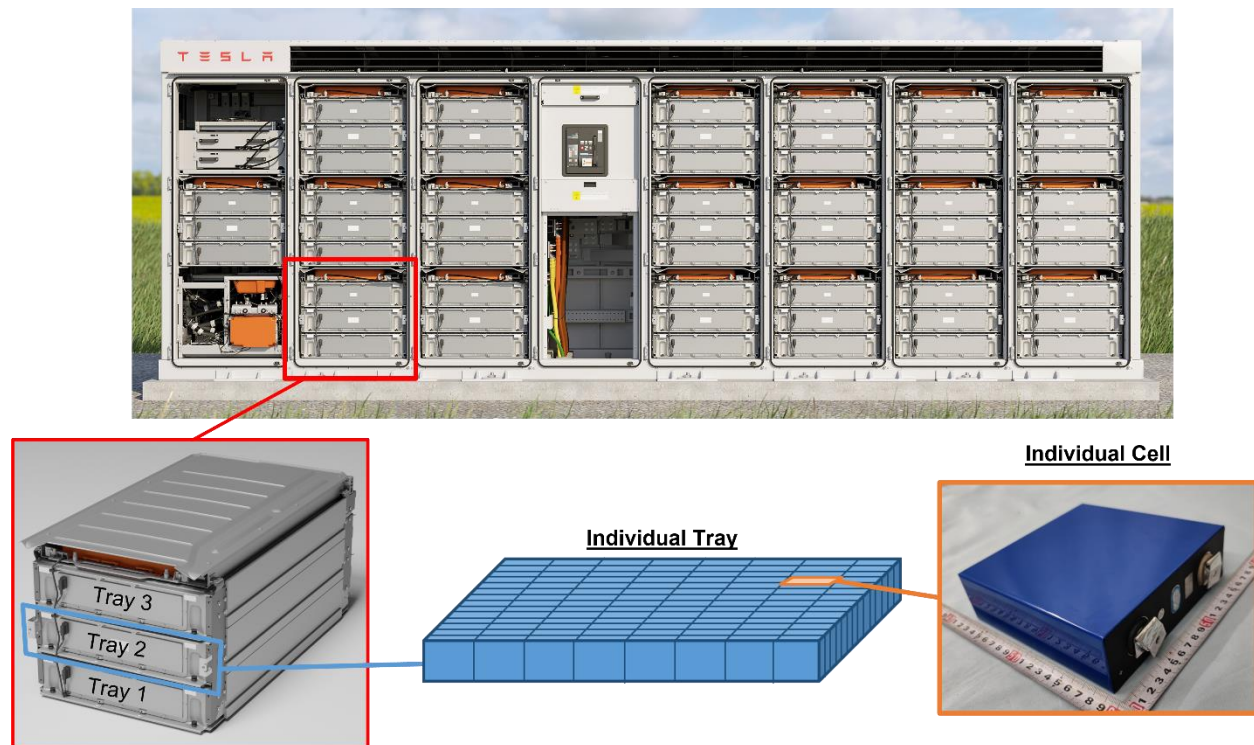
module contains three battery trays, as shown in Figure 2, which are arrays of prismatic, lithium phosphate (LFP) cells. The LFP cells (the cells) utilized in the MP2 are 157.2 Ah with a nominal voltage 3.22 Vdc and are individually hermetically sealed. They are approximately 50.75 millimeters (mm) by 166.0 mm by 169.3 mm and weigh 2,991 grams (g). Each battery tray contains 112 cells, as shown in Figure 2; meaning, each battery module has 336 cells and a fully populated MP2 (nineteen battery modules) can have up to 6,384 cells.

*Figure 2 MP2 unit layout, module layout, generalized tray layout, and an individual cell.*

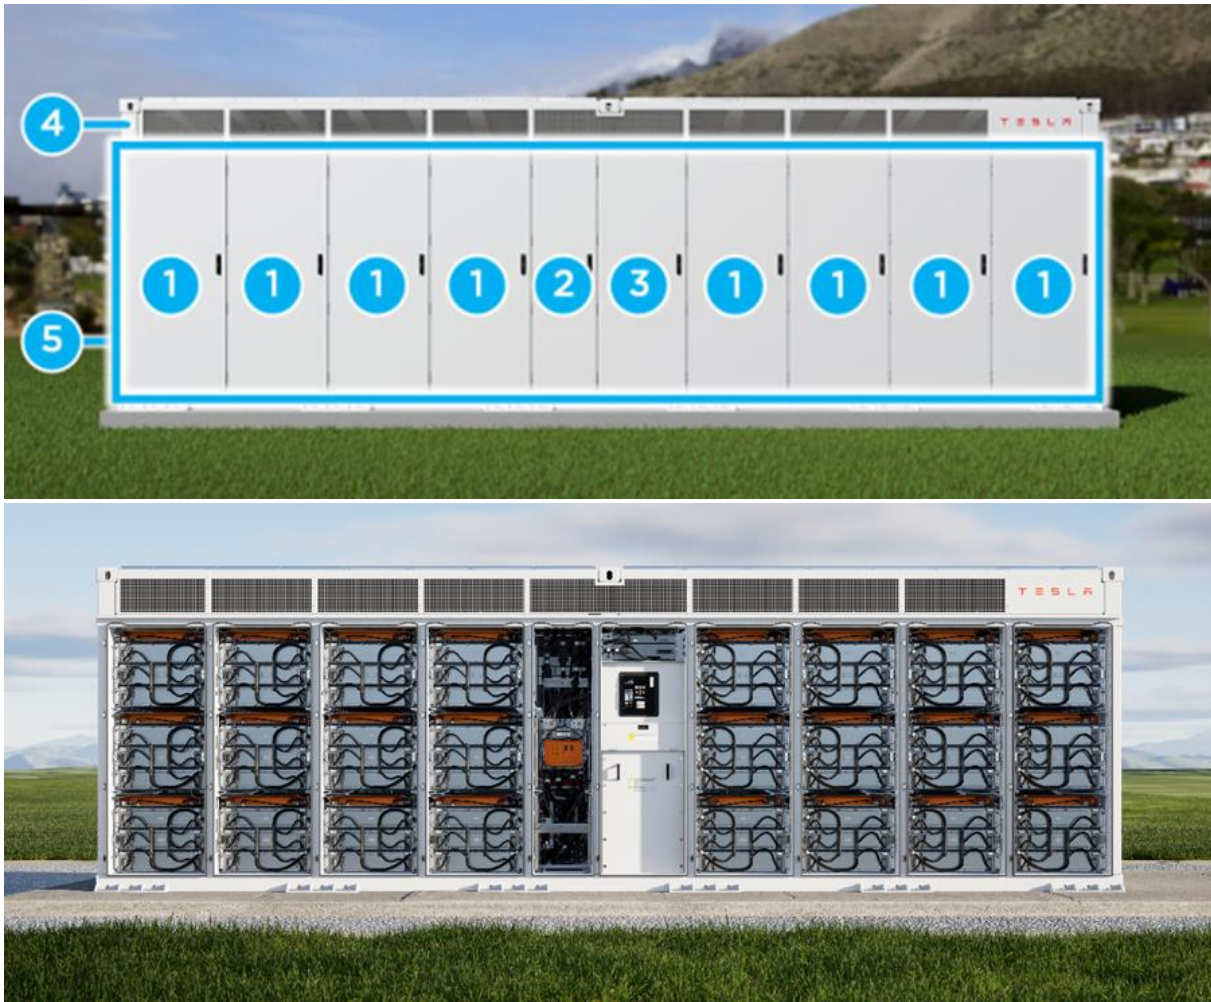
*Figure 3 MP2XL internal components: (1) Battery Module Bays, (2) Thermal Cabinet, (3) Customer Interface Bay, (4) IP20 Thermal Roof Enclosure, (5) IP66 Enclosure.*

For a more detailed discussion on the MP2XL components, their location, functionality, and purpose, refer to the MP2XL DIM. In addition, for a side-by-side direct comparison between the Megapack products, refer to Appendix 1, MP1 vs. MP2/2XL Comparison.

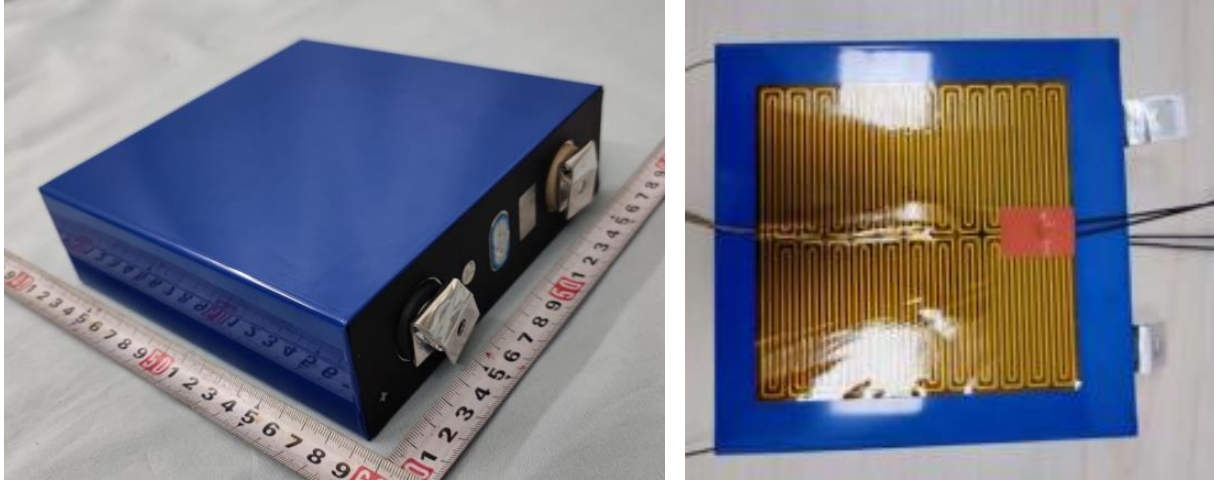
*Figure 4 Individual cell tested to UL 9540A (left) and installed film strip heater (right).*

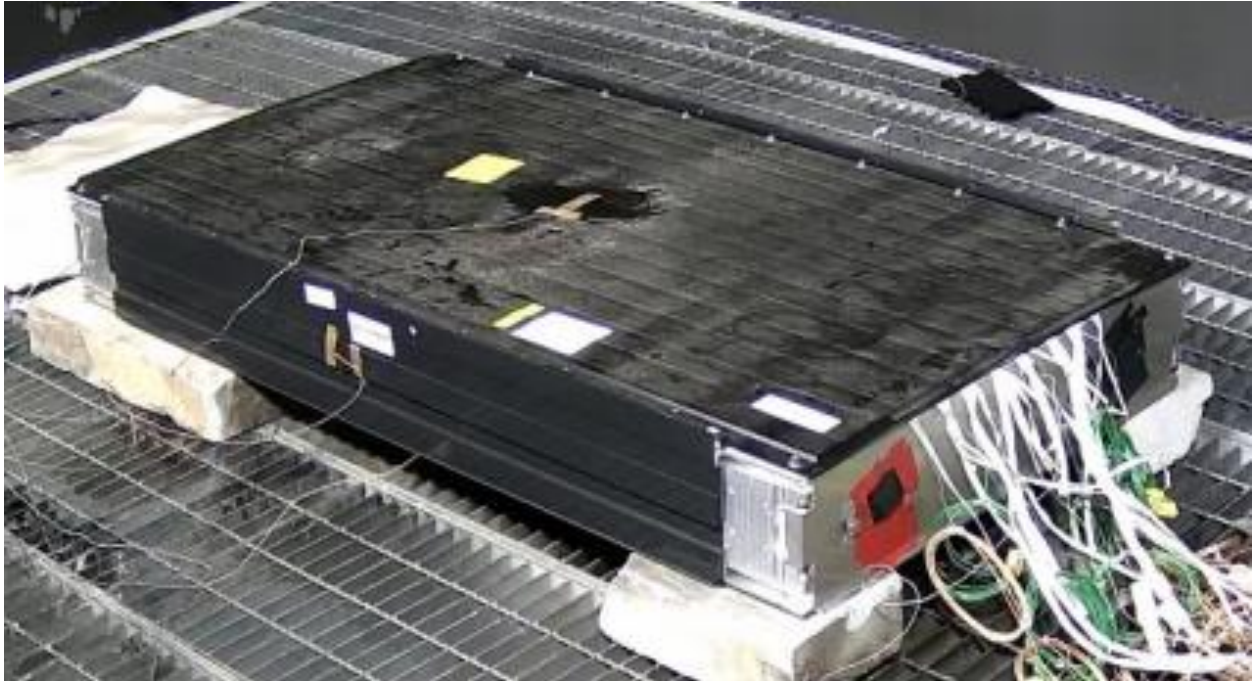
minute until the cells vented and went into thermal runaway. The tray was placed under an instrumented hood and the products released during combustion were collected and analyzed.

*Figure 5 Tray tested to UL 9540A module level testing.*

- Thermal runaway propagated from the initiating cells to all the cells in the MP2/2XL tray.
- Once ignited, the MP2/2XL tray took approximately 30-35 minutes to burn itself out.
- Based on the test observations and the HRR plot, a MP2/2XL tray fire appears to be a slow progressing thermal event (i.e., requiring over 30 minutes to burn itself out).
- Sparks and flying debris were observed, however, there were no explosive discharges of gases.
- Gases generated from the cell were identified as flammable, as listed in Table 2. However, toxic gases sometimes associated with lithium-ion batteries, such as HF, HCL, and HCN, were not detected during the combustion of the MP2/2XL tray.

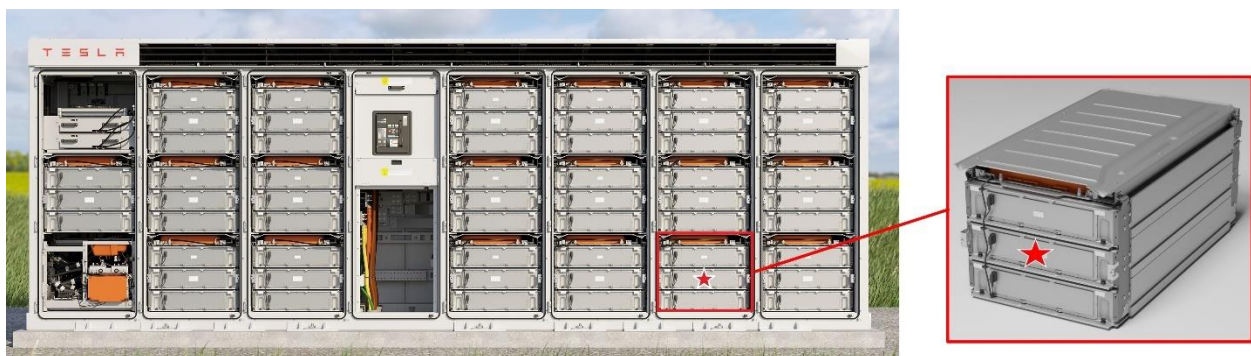
The initiating battery module was chosen to be the bottom battery module from Bay 7, in the middle battery tray, as shown in Figure 6. This location was deemed to be the worst-case, given there are battery trays directly above it and below it. In addition, by initiating in the bottom battery module, there are two additional battery modules installed directly above the initiation location. Within the battery tray itself, six interior cells were simultaneously heated via four film heaters, as shown in Figure 7. The heaters were programed to provide a heating rate of 5°C (9°F) per minute, as specified by UL 9540A. The number of cells and the location were selected to provide the greatest thermal exposure to adjacent cells to ensure cell to cell propagation during the test. The objective of this initiation method is to simulate a mass failure of multiple cells in a localized area within the same battery module.

*Figure 6 Initiation location: Bay 7, bottom battery module within tray 2.*

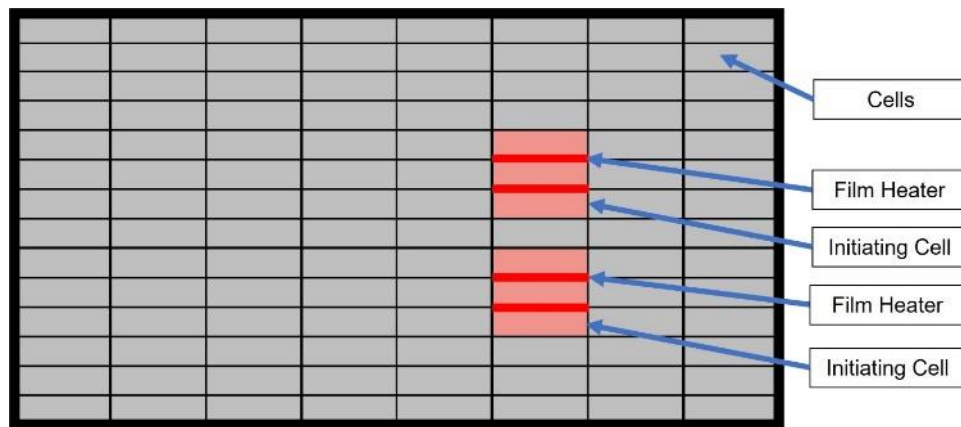
Figure 7 Film heater locations within the initiating tray.

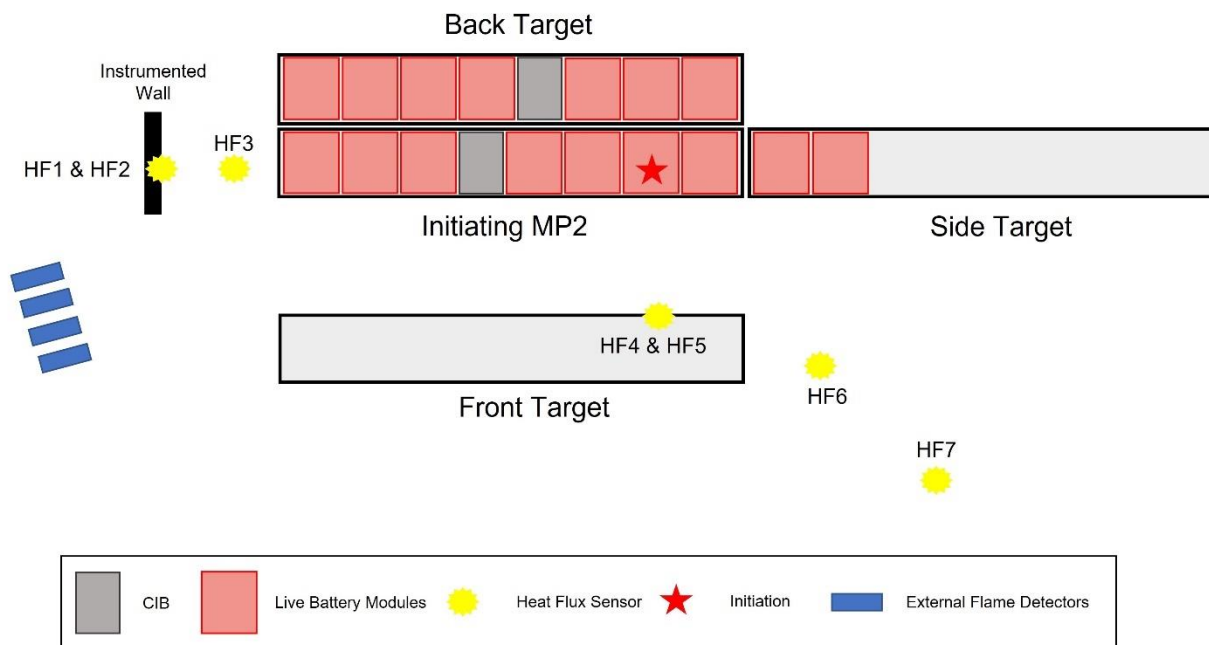
Outside the initiating battery module and MP2 cabinet, three additional target MP2 cabinets were installed: (1) 6 inches (in) or 150 mm behind the initiating MP2; (2) 6 in (150 mm) to the side of the initiating MP2; and (3) 8 ft (2.44 m) in front the initiating MP2, as shown in Figure 8.

Figure 8 Instrumentation and target MP2 cabinet setup (top view).

The two target MP2 cabinets behind and to the side were populated with 100% SOC battery modules to simulate a multiple MP2 cabinet installation and to determine if thermal runaway and/or fire will propagate from one MP2 cabinet to adjacent cabinets at separation distances of 6 in (150 mm). Additionally, a combustible, instrumented wall (wood framing with plywood

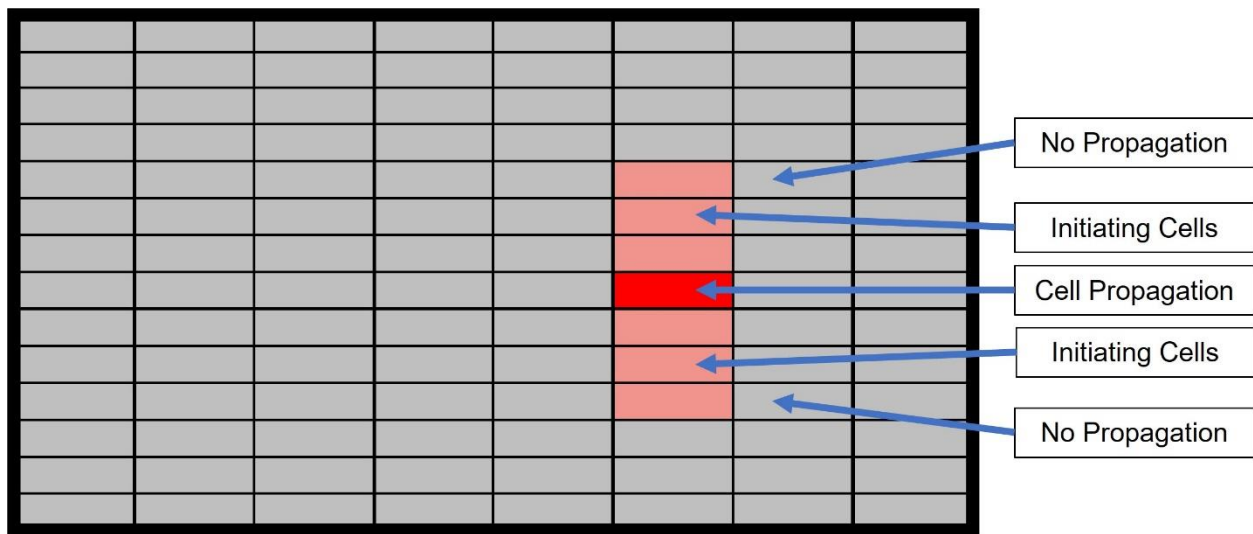
- Seven cells had gone into thermal runaway: the six that were forcibly heated and one additional cell, as illustrated in Figure 9. This demonstrated that cell to cell propagation had occurred during the test, as is required by UL 9540A.
- No other signs of distress were observed in the initiating battery module. Thermal runaway had not propagated beyond the seven cells within Tray 2, nor had it spread to the tray above or below it within the battery module.

*Figure 9 Cell propagation during UL 9540A unit level fire testing: six initiating cells (pink), one cell experiencing thermal runaway propagation (red), and cells without thermal runaway propagation (grey cells).*

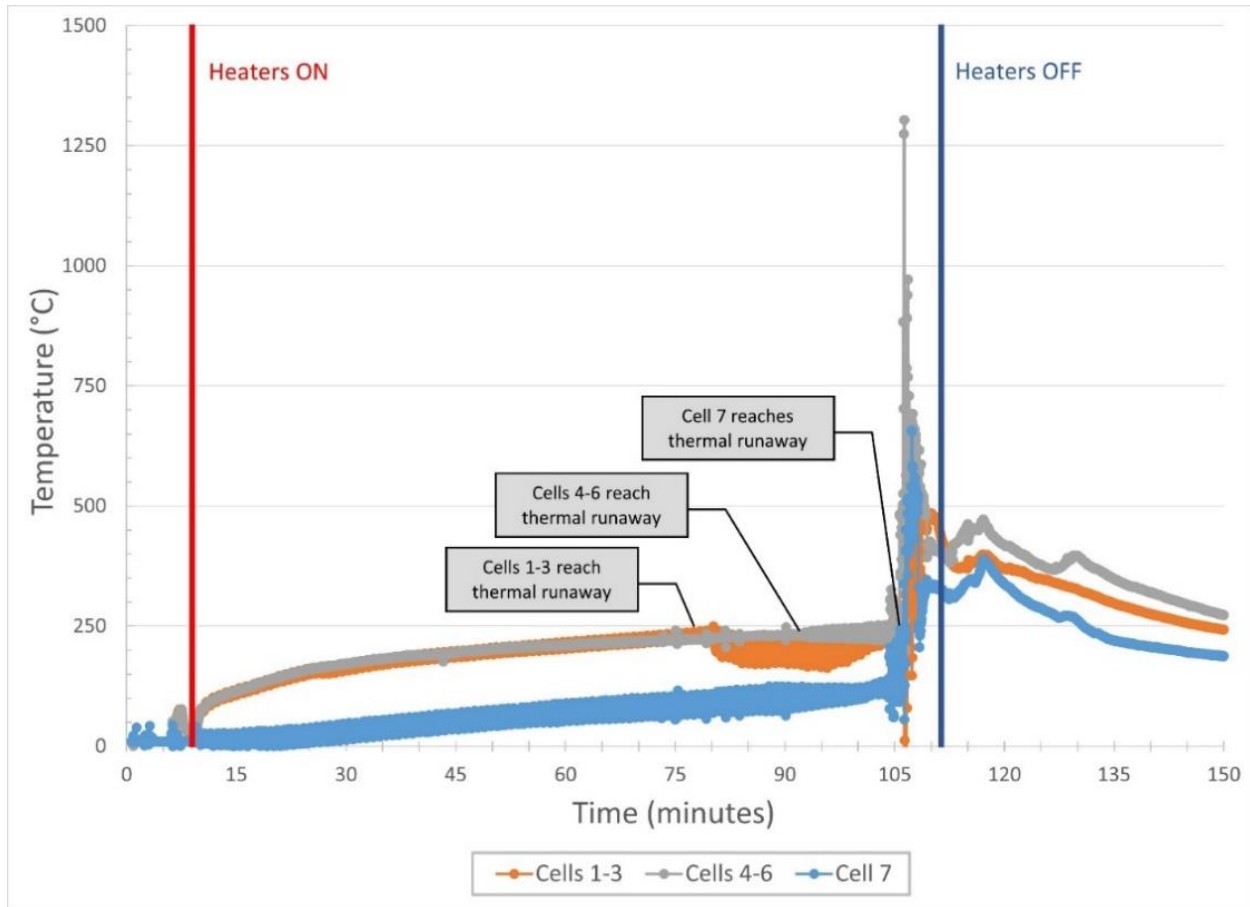
*Figure 10 Cell surface temperatures recorded during UL 9540A unit level fire testing. Approximate Time to Thermal Runaway: Cells 1-3: 78 minutes; Cells 4-6: 93 minutes; and Cell 7: 105 minutes.*

UL 9540A unit level fire testing of the MP2 demonstrated that an internal failure event causing thermal runaway of six cells nearly simultaneously will not propagate thermal runaway throughout the battery module. The nearly simultaneous failure resulted in thermal runaway propagating only to one additional cell and no further. The first group of initiating cells went into thermal runaway approximately 1-hour and 18 minutes into the test, as shown in Figure 10. This observation is based on internal thermocouple measurements installed on the surface of the cells within the initiating battery module. Fifteen minutes later the second group of initiating cells went into thermal runaway and cell to cell propagation was confirmed at approximately 1-hour 45 minutes when a seventh cell reached of 239°C (462°F). Note, this result was with a disabled

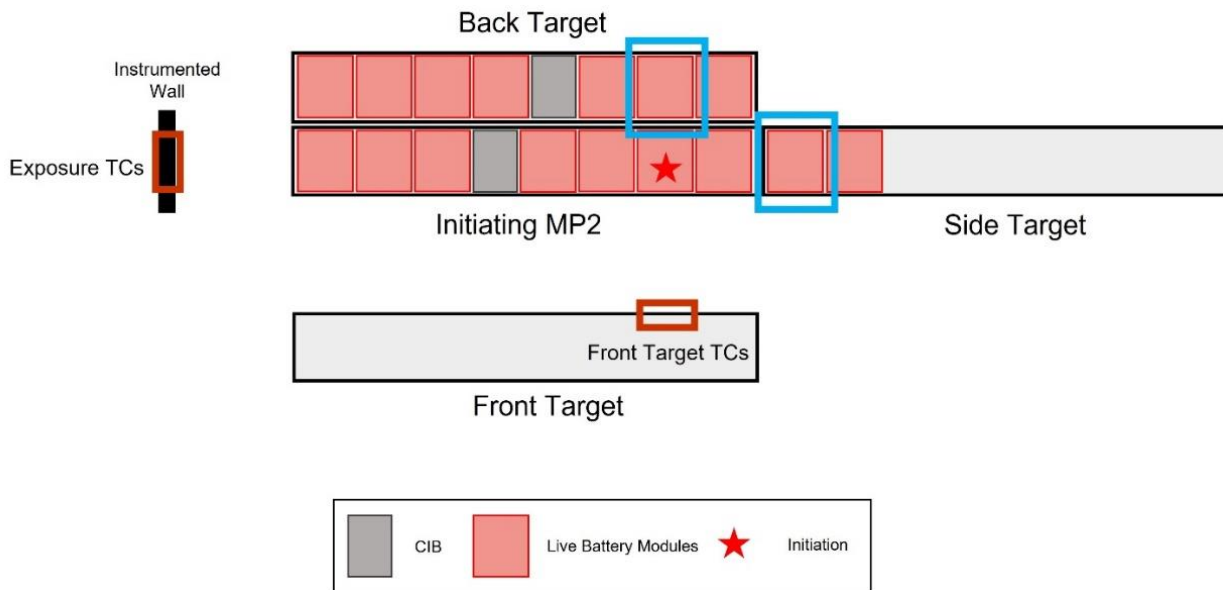
These temperatures were recorded at the battery modules closest to the initiating battery module, as shown in Figure 11. As plotted in Figure 12, the internal temperature of the target battery modules gently rose throughout the 2½-hour test as the ambient, outdoor temperature also increased from 10.3°C to 11.6°C. These temperature measurements indicate the target battery modules were not affected by the thermal runaway of the seven cells within the initiating battery module.

*Figure 11 Location of temperature measurements at side and back target battery modules (blue boxes) and the front target and side exposure surface temperatures (brown boxes).*

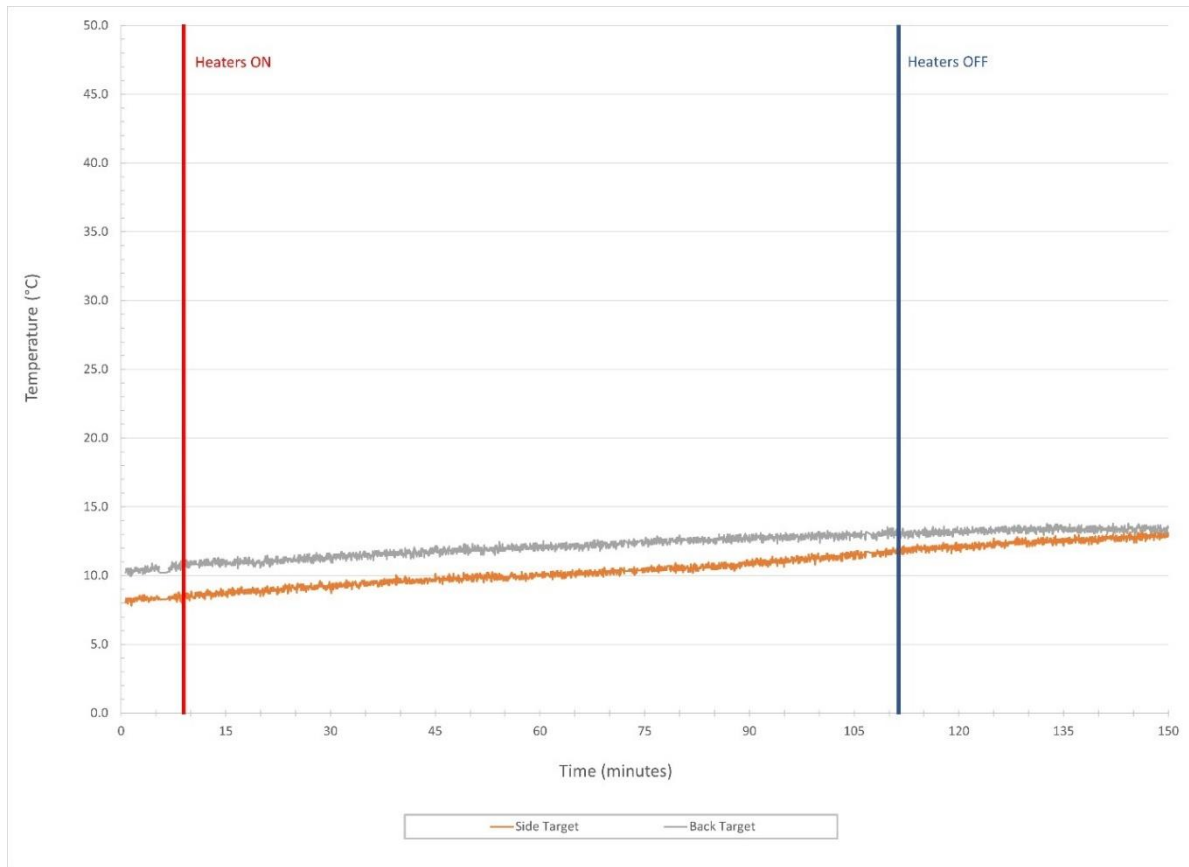
*Figure 12 Side and back target battery module temperatures during UL 9540A unit level fire testing.*

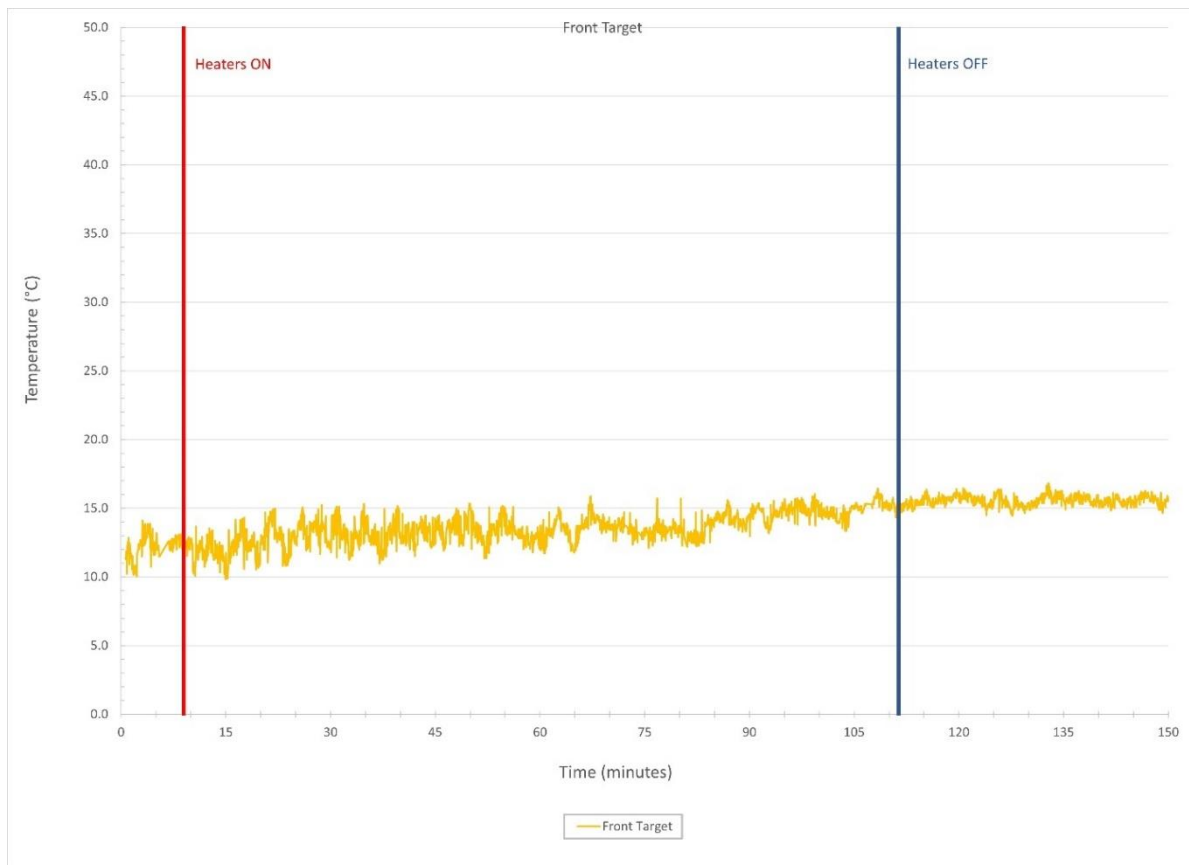
(52.3°F) to a maximum surface temperature of 16.8°C (62.2°F). Similarly, as plotted in Figure 14, the 24 thermocouples installed on the instrumented wall also gently rose throughout the test and fluctuated slightly with the outdoor environmental conditions (i.e., wind blowing, sun exposure, increasing ambient temperatures). The maximum temperature measured on the instrumented wall was 25.9°C (78.6°F), which was temperature rise of 5.5°C (9.9°F) above its ambient temperature at the start of the test. Note, the temperature rise above ambient reported in Table 5 can be attributed to the environmental conditions during the 2½-hour test and are not directly related to the thermal runaway of the seven cells within the initiating MP2. As these measurements are surface temperatures, the temperature rise within the front target surface and the instrumented wall surface is predominantly due to the sun heating up those surfaces during the test (the test was run between 11 am and 1:30 pm on a mostly sunny day). These temperature measurements indicate an exposure surface 5 ft (1.52 m) to the side and adjacent MP2 cabinets 8 ft (2.44 m) in front were not affected by the thermal runaway of the seven cells within initiating battery module.

*Figure 13 Front target external surface temperature 8 ft (2.44 m) directly in front of the initiating module.*

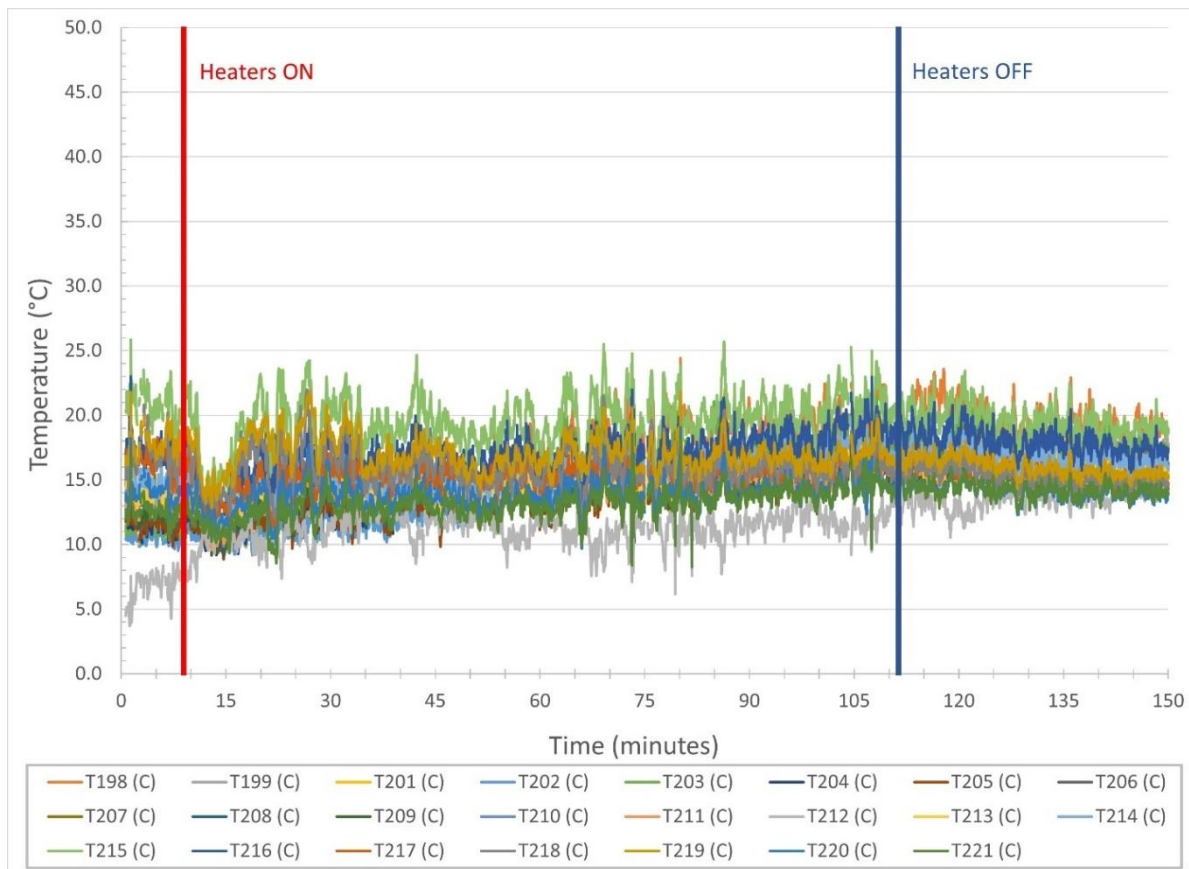
*Figure 14 Instrumented wall surface temperatures during UL 9540A unit level fire testing. (Note: T200, the 24<sup>th</sup> thermocouple installed on the instrumented wall, did not work during testing, and was therefore removed from this plot as the measurements recorded were erroneous).*

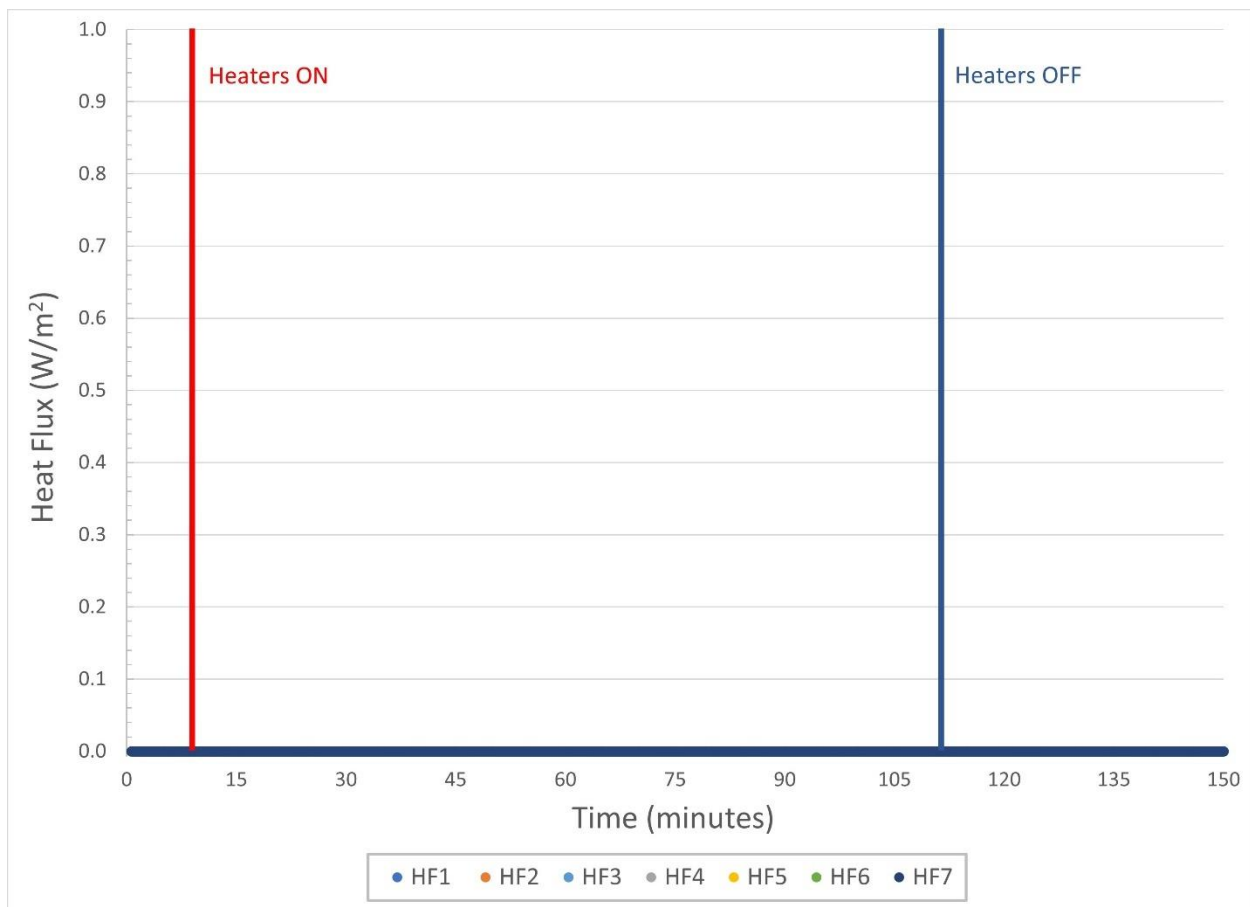
*Figure 15 Heat flux measurements recorded during UL 9540A unit level fire testing.*

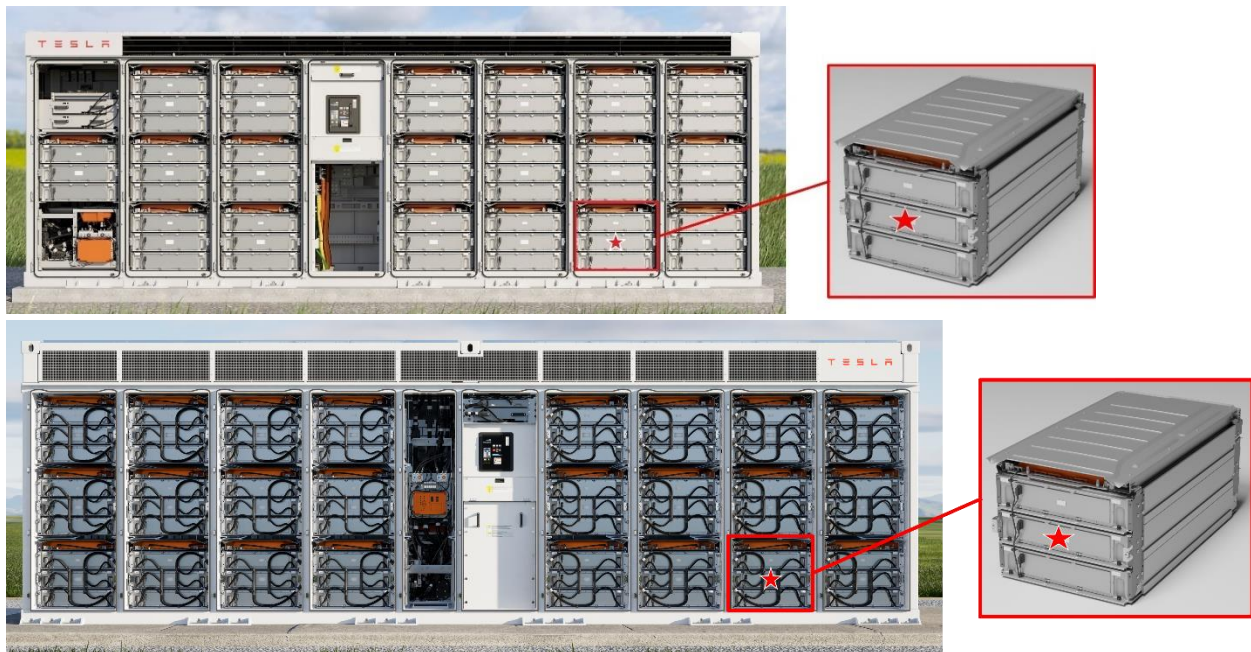
Figure 16 MP2 vs. MP2XL internal components comparison.

Similarly, after reviewing the MP2 unit level fire test results and comparing the MP2 and MP2XL products to one another, TÜV determined the MP2 UL 9540A unit level fire test results can be applied to the MP2XL and an additional UL 9540A unit level fire test for the MP2XL was not required for its listing. As such, given all these factors, a stand-alone MP2XL unit level fire test was not performed, nor required. The UL 9540A unit level fire test results, described above for the MP2, can be applied to the MP2XL.

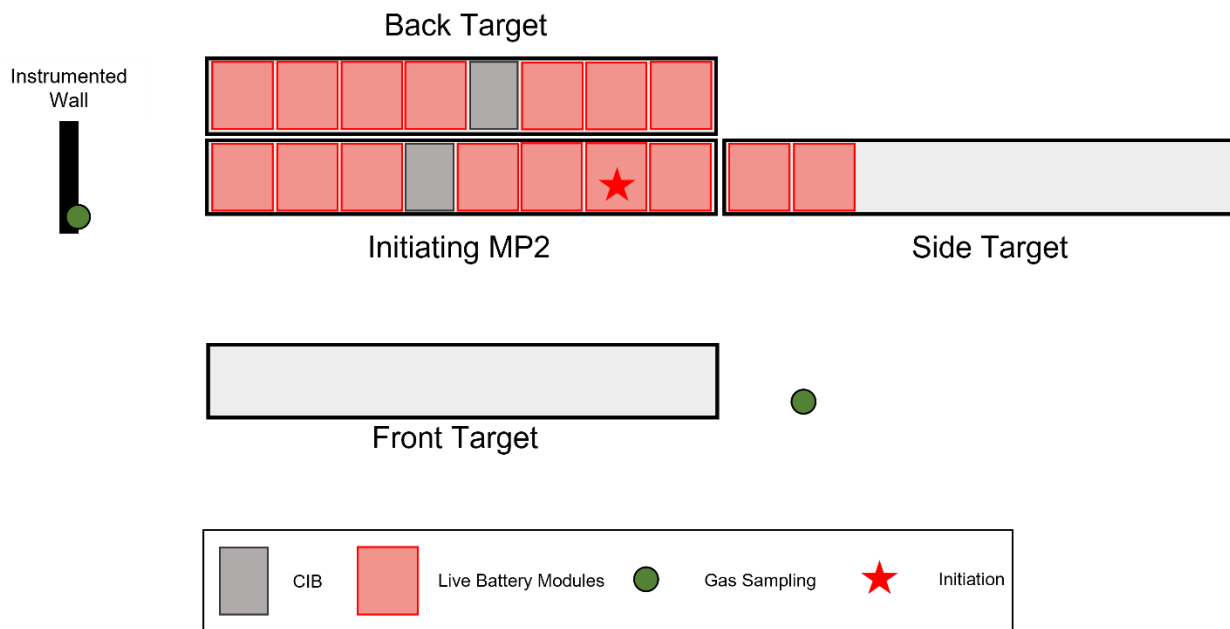
Products of combustion are not required to be collected during the outdoor UL 9540A unit level fire test; however, they were collected during cell and module level testing, as summarized previously. To provide additional products of combustion data during a unit level test, gas samples were collected during an internal, unit level fire test performed by Tesla on the MP2. This test was performed just as described above for the UL 9540A unit level test with gas samples being collected at two different locations: approximately 20 ft upwind and 5 ft downwind from the initiating MP2, as shown in Figure 17.

*Figure 17 Unit level products of combustion test setup.*

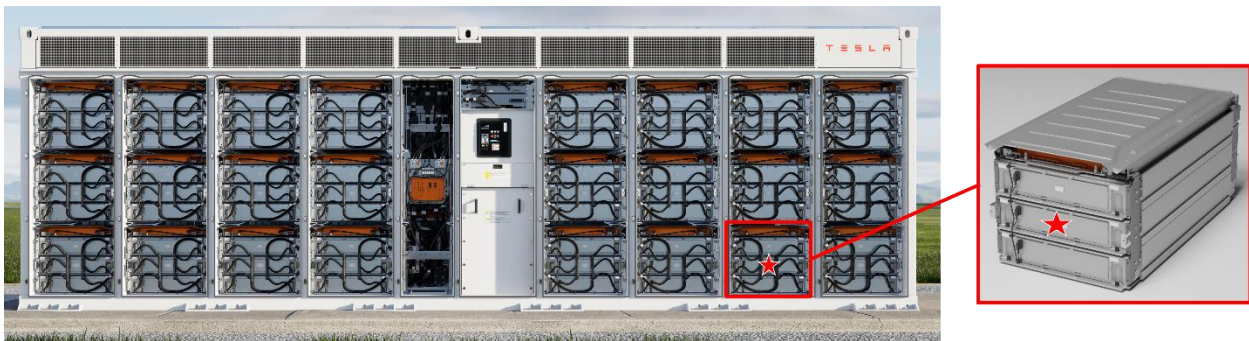
The test was performed in the spirit of the UL 9540A unit level fire test method; however, it was not performed precisely to the test method given the objective of the test was to create a severe failure scenario, well beyond what is contemplated by the UL test methods. As such, one MP2XL cabinet was positioned on a concrete pad in the open air for testing. No additional target cabinets were installed around it. Identical to the UL 9540A unit level fire test described above, the initiating battery module was chosen to be the bottom battery module from Bay 9, in the middle battery tray (tray #2), as shown in Figure 18.

*Figure 18 Initiation location: Bay 9, bottom battery module, tray #2.*

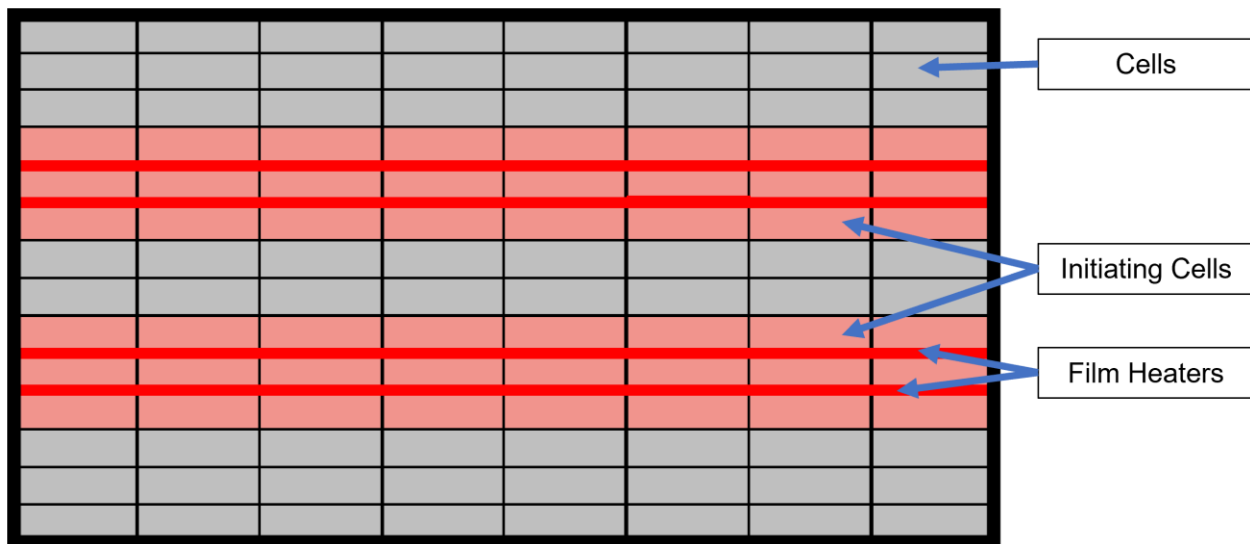
Within the battery tray itself, forty-eight interior cells were simultaneously heated via thirty-two film heaters, as shown in Figure 19. The heaters were programed to provide a heating rate of 5°C (9°F) per minute, as specified by UL 9540A. The number of cells and the location were selected to provide the greatest thermal exposure to adjacent cells to ensure cell to cell propagation during the test. The objective of this initiation method is to simulate a mass failure of nearly half the tray in order to force a thermal event.

*Figure 19 Film heater locations within the initiating tray.*

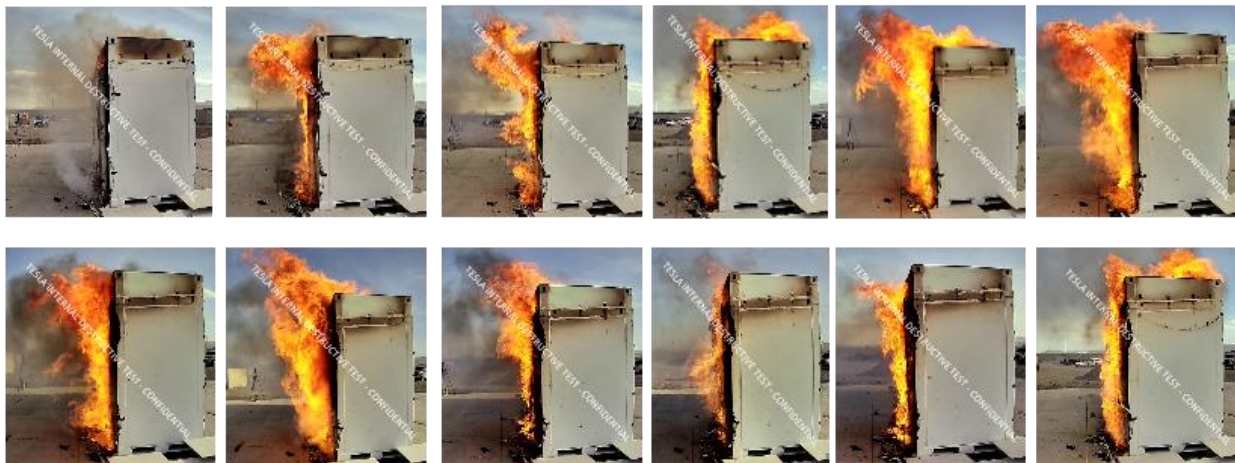
- Fire spread from battery bay to battery bay was a slow progressing event. In total, visible flames were observed for 6 hours and 40 minutes while the four battery bays (bays 7-10) burned, as shown in Figure 20.

*Figure 20 Fire progression during unit level destructive testing (first three hours): images captured every 15 minutes moving left to right. Initial flaming (top left), peak flame intensity occurring 60-90 minutes after initial flaming (top right) before diminishing for the remainder of the test (bottom left to right).*

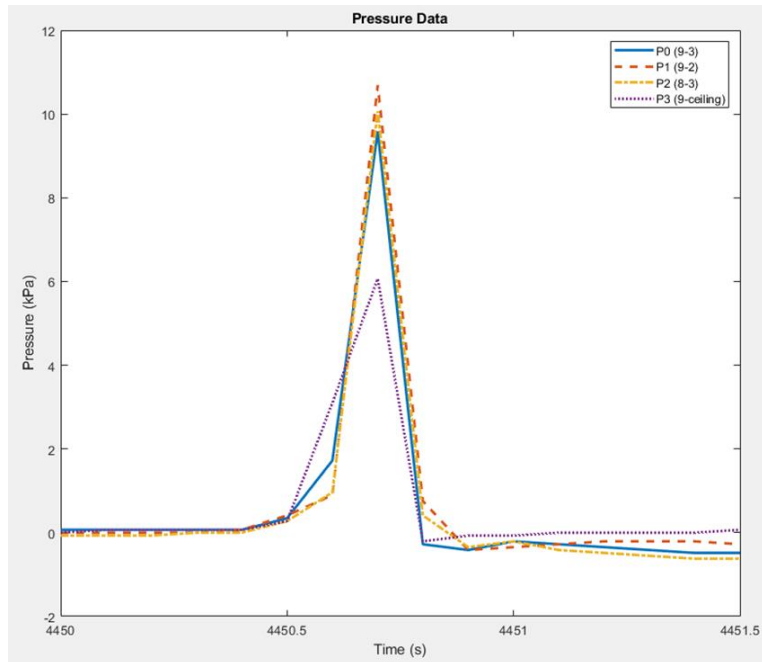
pressure diminished. The overpressure vents are designed to operate at approximately 12 kPa (1.74 psi), or 2.5 times below the cabinet's strength of 30 kPa (4.35 psi).

*Figure 21 Pressure profile inside the MP2XL cabinet just before and after the thermal event.*

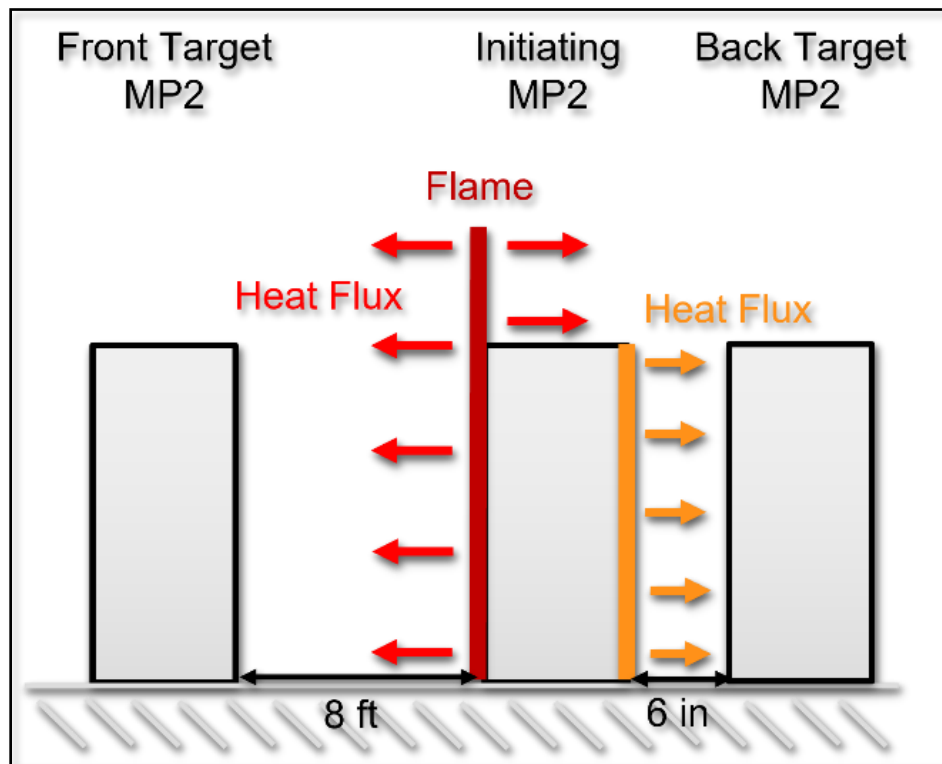
*Figure 22 Heat flux model conditions: no wind condition.  
Note: the illustration is for demonstrational purposes only. Not to scale.*

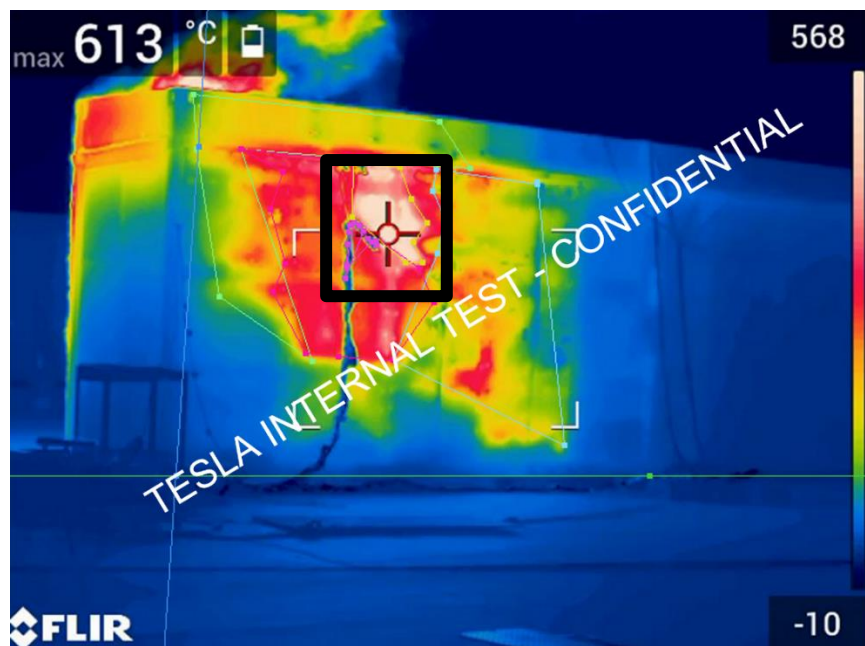
To validate the heat flux model, it was first applied to a fire test performed on the original Megapack (MP1). During unit level fire testing of the MP1, a fire event consumed the entire cabinet and external heat fluxes were collected by heat flux sensors. The inputs for the model were determined by reviewing the fire test videos and thermal imager data.

*Figure 23 Typical “hot spot” (see black box) observed during the destructive unit level test.*

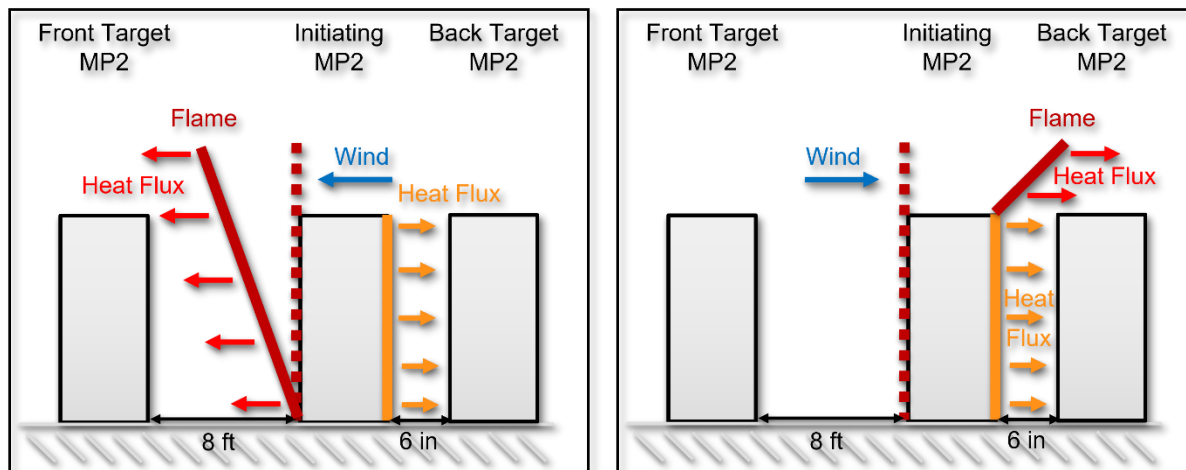
*Figure 24 Heat flux model conditions: with wind blowing towards the front target (left) and with wind blowing towards the back target with flames exiting the top of the MP2 cabinet (right). Note: the illustrations are not to scale.*
