PROJECT NAME  
**Tesla Megapack 2 and  
Megapack 2XL**

DATE SUBMITTED  
**January 23, 2023**

**Fire Protection  
Engineering Analysis**

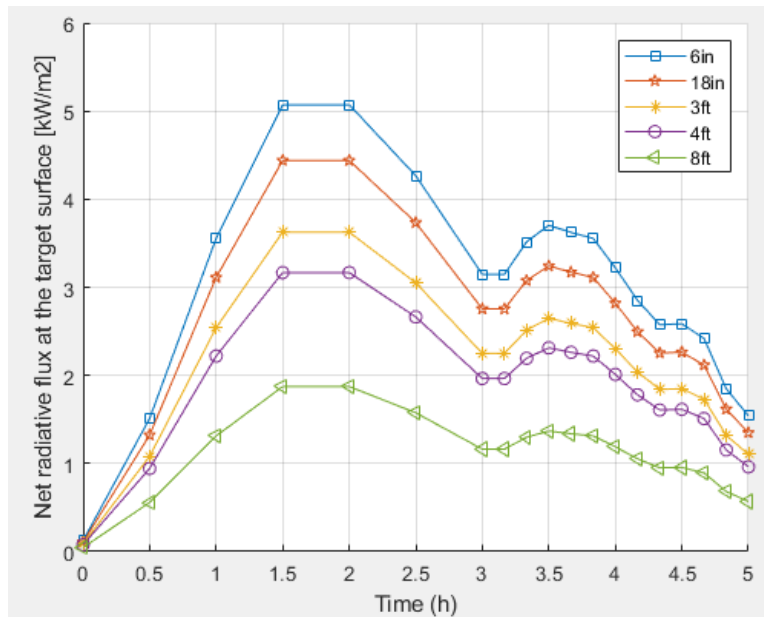
The heat flux model determined the anticipated heat flux emitted from a MP2/2XL fire as a function of time for each of the scenarios described above. Figure 25 provides the modeled heat fluxes emitting off the hot MP2/2XL cabinet surface only (i.e., excluding the flame heat flux) as a function of time, Figure 26 provides the modeled heat fluxes emitting off the flames for the three wind conditions described above, and Table 8 provides the peak heat fluxes determined by the models for each scenario.

Figure 25 Heat flux emitting off the MP2 cabinet surface, as a function of time, at varying distances as determined by the heat flux model.

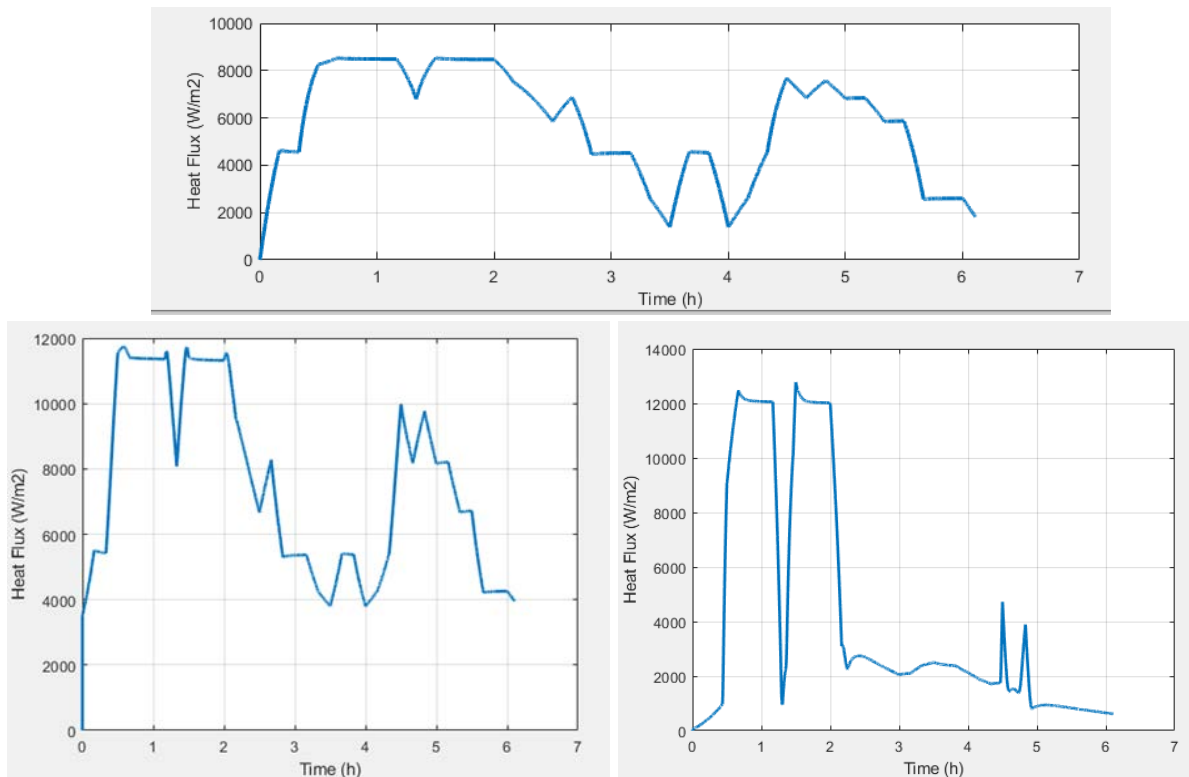
Figure 26 Heat flux emitting off the flames, as a function of time, as determined by the heat flux model: no wind condition (top); wind blowing towards the front target (bottom left); and wind blowing towards the back target (bottom right).

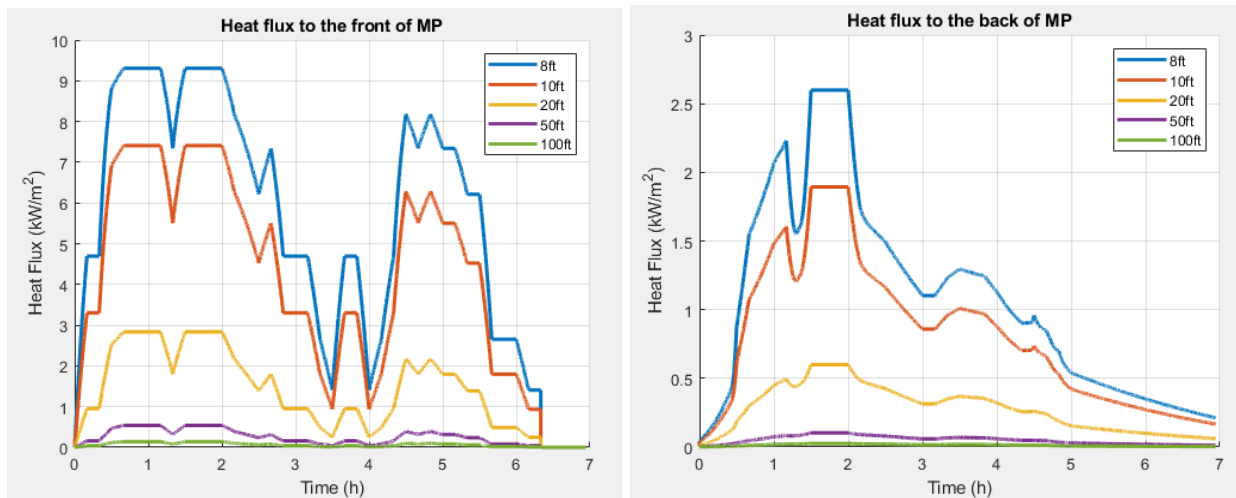
In addition to creating heat flux profiles for the purpose of analyzing the fire propagation risk to neighboring MP2/2XL cabinets, the heat flux model was also utilized to determine the estimated heat fluxes at distances further from the MP2/2XL cabinet, as shown in Figure 27. These values can be utilized, as necessary, to analyze the risk to other exposures in proximity to a MP2/2XL.

*Figure 27 Heat flux versus time as determined by the heat flux model in front of the MP2 cabinet (left) and behind the MP2 cabinet (right).*

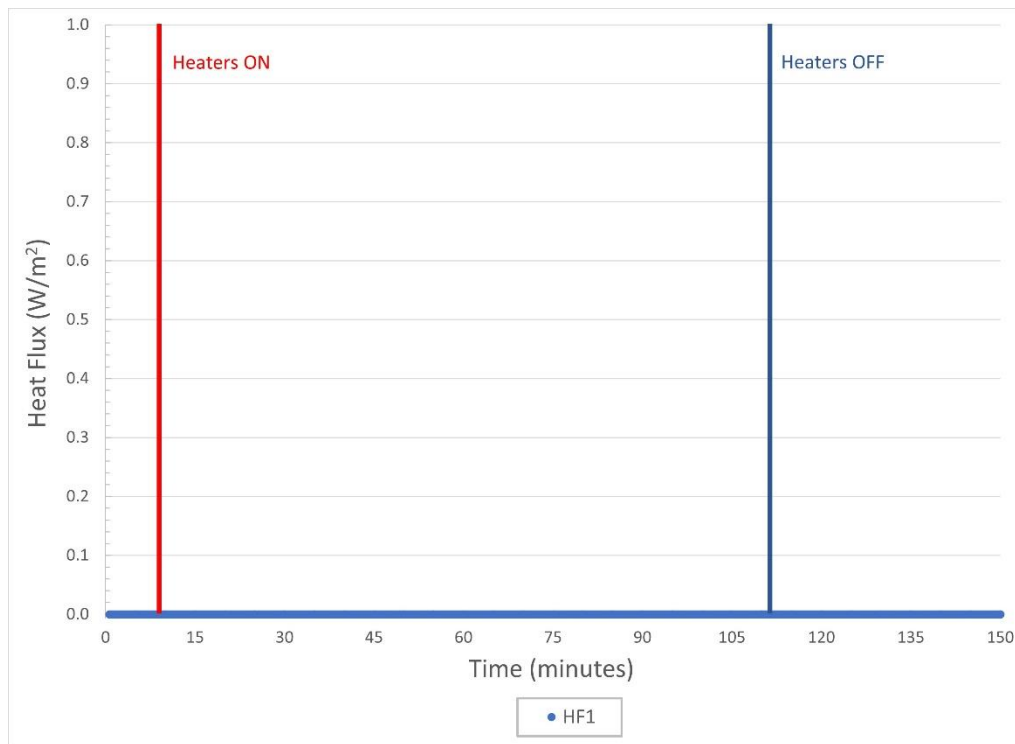
Figure 28 HF1 measurements recorded during UL 9540A unit level fire testing.

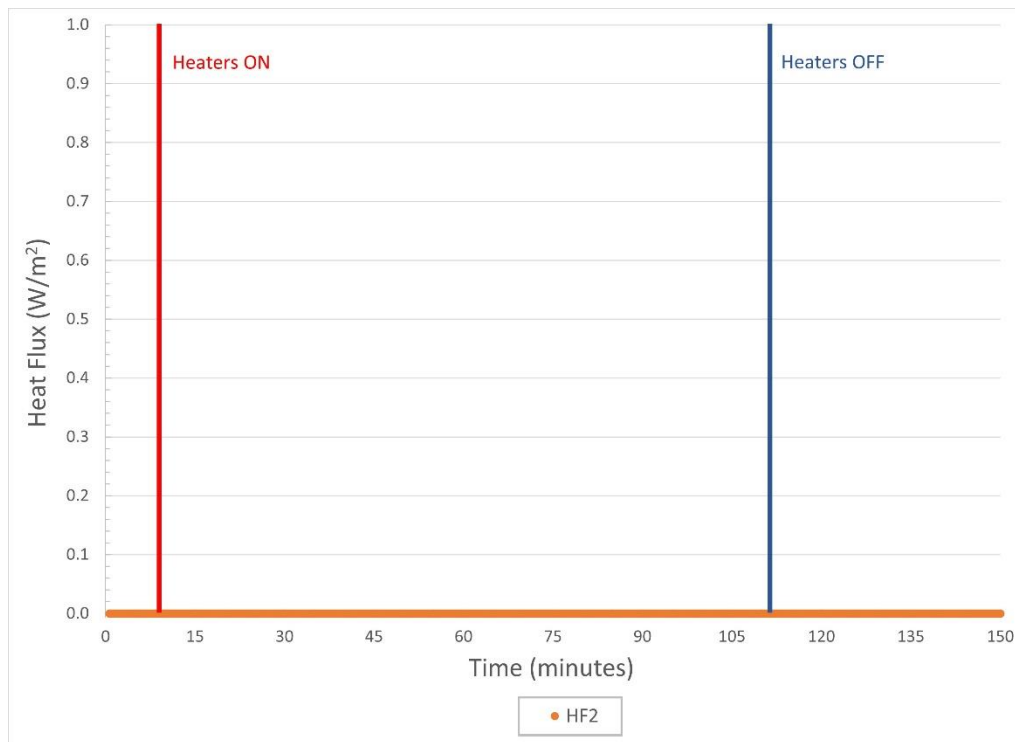
Figure 29 HF2 measurements recorded during UL 9540A unit level fire testing.

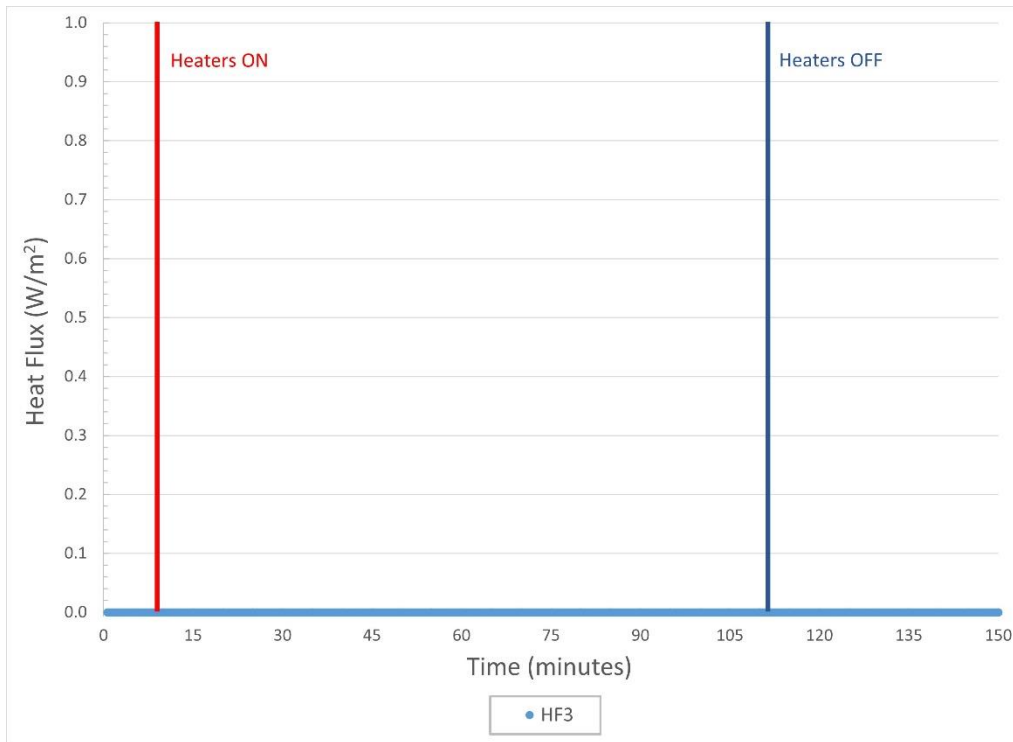
Figure 30 HF3 measurements recorded during UL 9540A unit level fire testing.

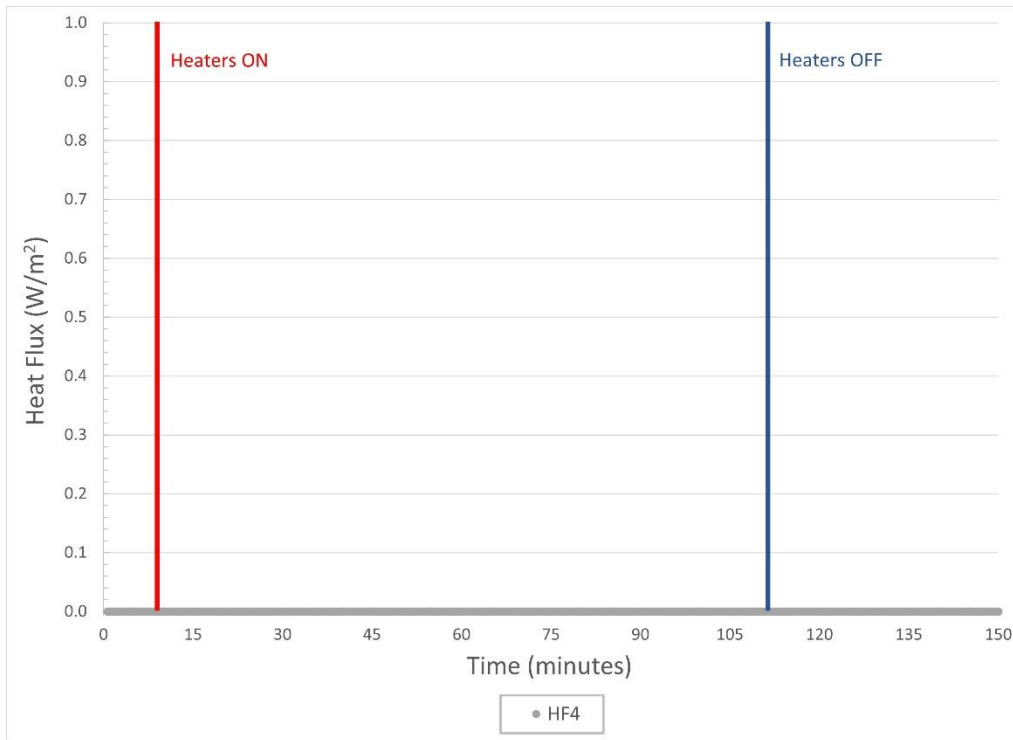
Figure 31 HF4 measurements recorded during UL 9540A unit level fire testing.

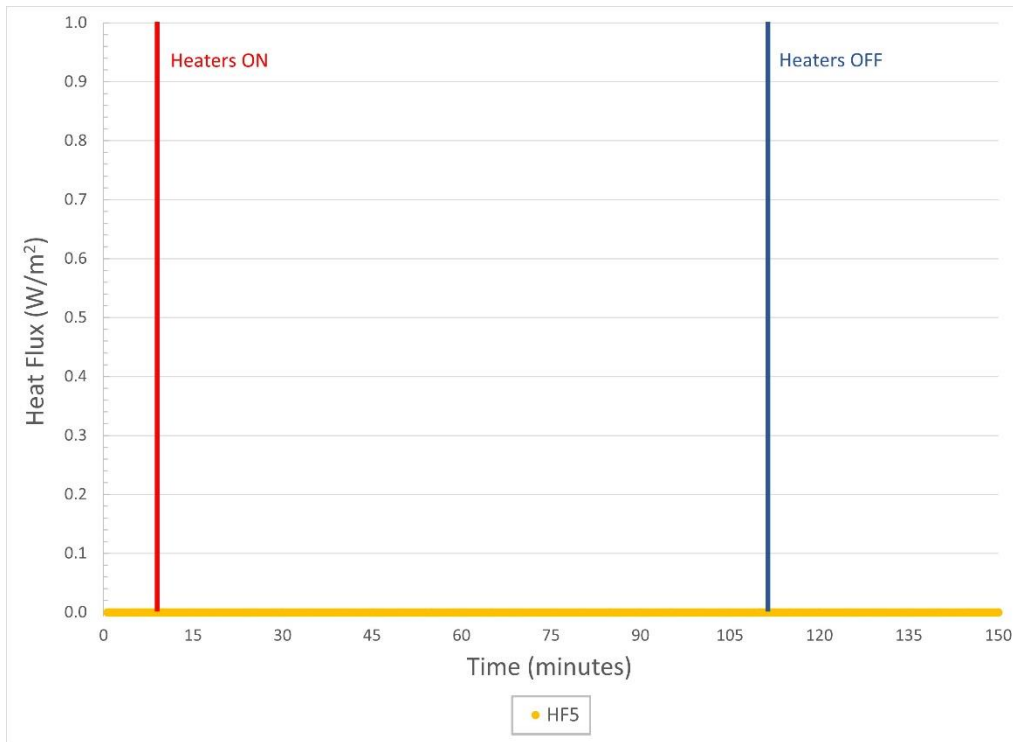
Figure 32 HF5 measurements recorded during UL 9540A unit level fire testing.

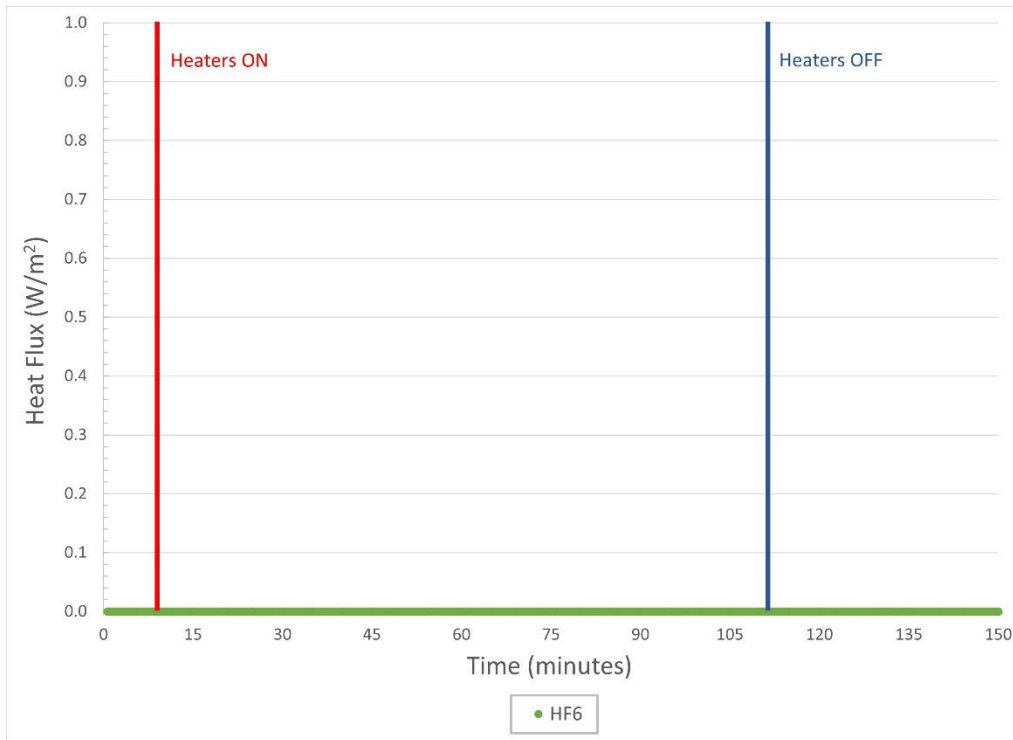
Figure 33 HF6 measurements recorded during UL 9540A unit level fire testing.

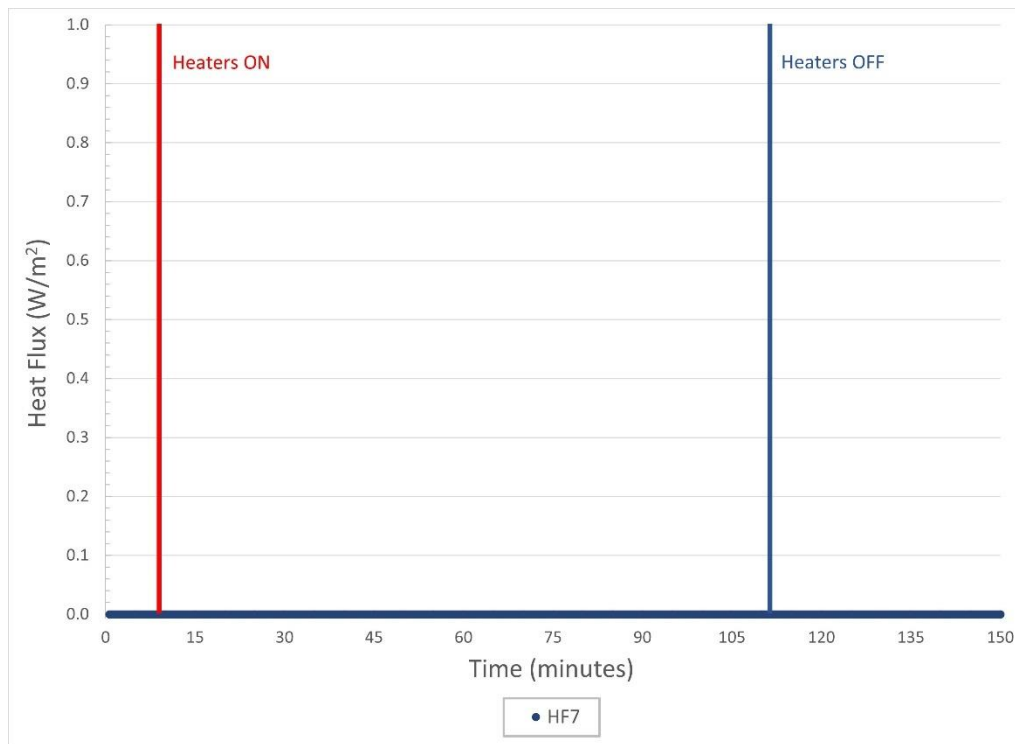
Figure 34 HF7 measurements recorded during UL 9540A unit level fire testing.
